# Effect of Microfissures on Corrosion Performance and Mechanical Properties of Austenitic Stainless Steel Weld Metals

Yan Cui

*University of Tennessee - Knoxville*

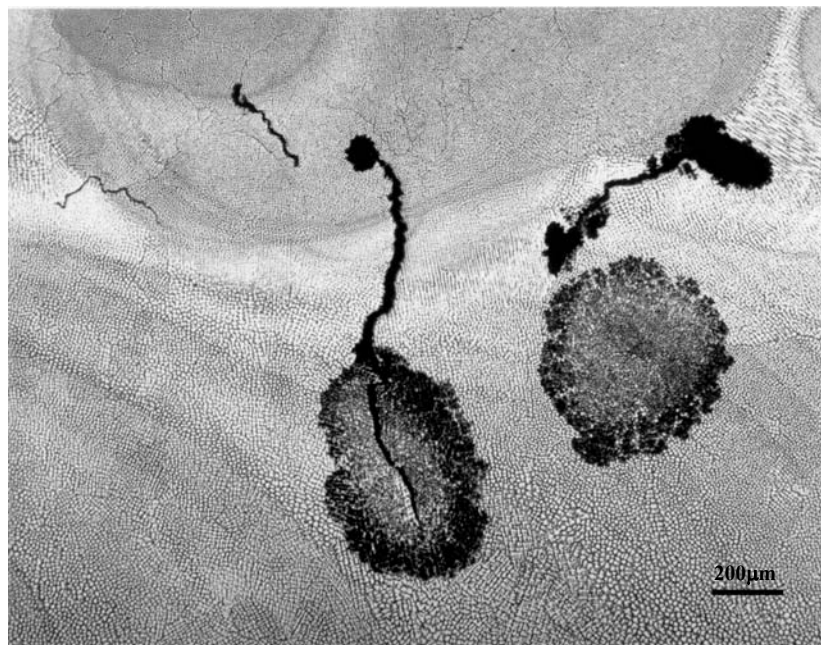
Figure 4.20 Photomicrographs of M316H before and after cyclic polarization test (3.5% sodium chloride at 22°C in deaerated conditions), 50X.
